**Flood Control Project Maintenance  
Levee Inspections**

**Spring 2016 Levee Inspection Results**

**Yolo County Service Area 6**

Waterway				Bank	Unit Miles
Unit No. 01 Right Bank of Sacramento River at Knights Landing				Right	5.87
	Spring (March - May)	Summer (June - August)	(September - November) Fall	Winter (December - February)	
Unit Maintenance Rating (Fall Only)					
Date of Inspection	4/12/2016 - 4/12/2016				
DWR Inspector	Jai Lor				
Accompanied By

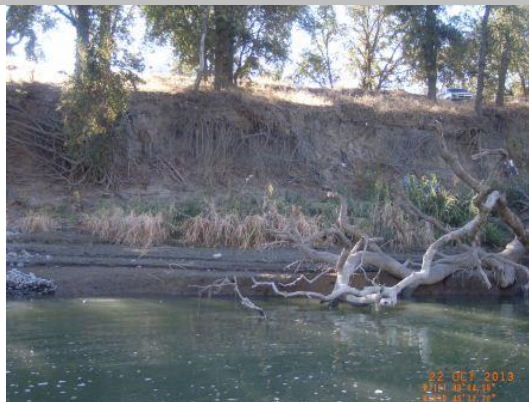
Photo 1 of 3 : SP\_2016\_NA0022\_350\_4\_20160304\_00003.jpg

LM Start	5.67	Rating **	M	Issue No.	4
LM End	5.85	Issue Type +	Ma	Location *	WS
Category	Supplemental			GPS Latitude/Longitude	
				Start	End
Item	2015 USACE Erosion Survey, DRAFT			38.759000 °	38.759390 °
				-121.670759 °	-121.667500 °
DWR ID	DWR_NA0022_01_s_2016_4				
Comment Code					
Inspector Comment					
2006 - Approximately 18 to 20 ft of bank near levee at the corner of the levee and the Freemont Weir. Vertical bank with undercutting/mass failure. 2007 - Staked at top of bank for monitoring. 2011 - Site has become significantly worse with more of the toe and lower bank eroded. Many trees have fallen since last year. 2012 - Site looks worse with more ersion around trees. 2013 - Additional erosion into the toe. 2015: Site extended upstream about 500 ft to account for eroding bank. [2015 Site ID: SAC_83-9_R]

USACE 2013 Photo #1

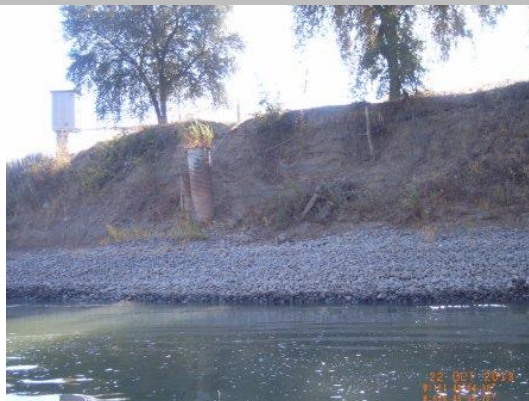
Photo 2 of 3 : SP\_2016\_NA0022\_350\_4\_20160304\_00004.jpg

2006 - Approximately 18 to 20 ft of bank near levee at the corner of the levee and the Freemont Weir. Vertical bank with undercutting/mass failure. 2007 - Staked at top of bank for monitoring. 2011 - Site has become significantly worse with more of the toe and lower bank eroded. Many trees have fallen since last year. 2012 - Site looks worse with more erosion around trees. 2013 - Additional erosion into the toe. 2015: Site extended upstream about 500 ft to account for eroding bank. [2015 Site ID: SAC\_83-9\_R]

USACE 2013 Photo #2

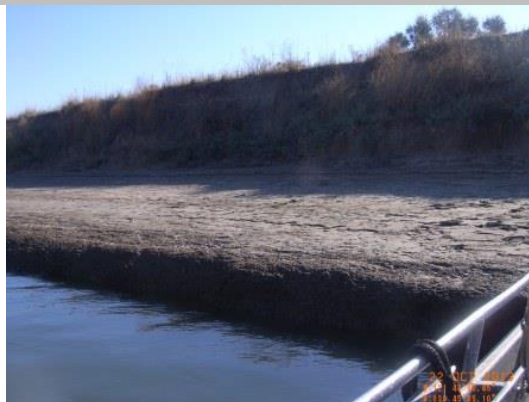
Photo 3 of 3 : SP\_2016\_NA0022\_350\_4\_20160304\_00005.jpg

USACE 2013 Photo #3
